How Piston Rod Vibration Signaled a Reciprocating Compressor Problem

The Value of a Monitoring System After Machine Maintenance Has Been Performed

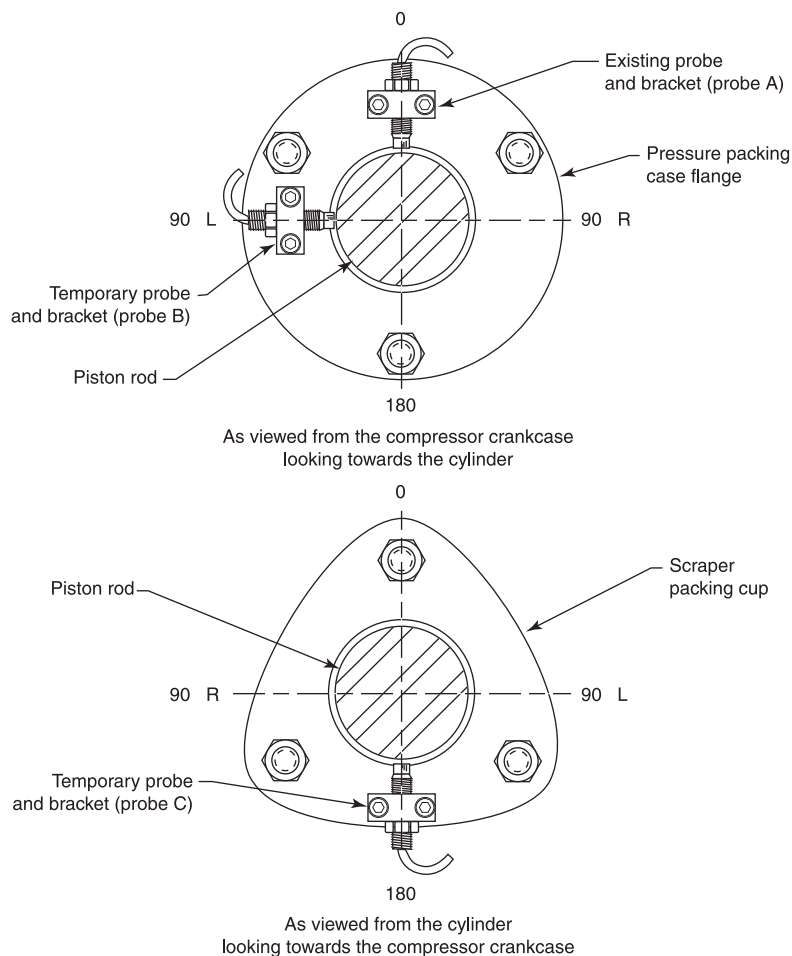
FIGURE 1

To gain more information about the machine operation, additional proximity probes were installed to view piston rod motion on the machine (Figure 1). Supplementing the existing probe (hereafter, referred to as probe A) installed at the pressure packing case at top dead center (TDC), were two additional probes: one mounted at 90 degrees left (as viewed from the compressor crankcase to the cylinder), and the second installed at the scraper packing at bottom dead center (BDC). These will be referred to as probes B and C,

TRANSDUCER INSTALLATION DETAILS SHOWING EXISTING PROBE (A) AND SUPPLEMENTARY TEMPORARY PROBES (B AND C)

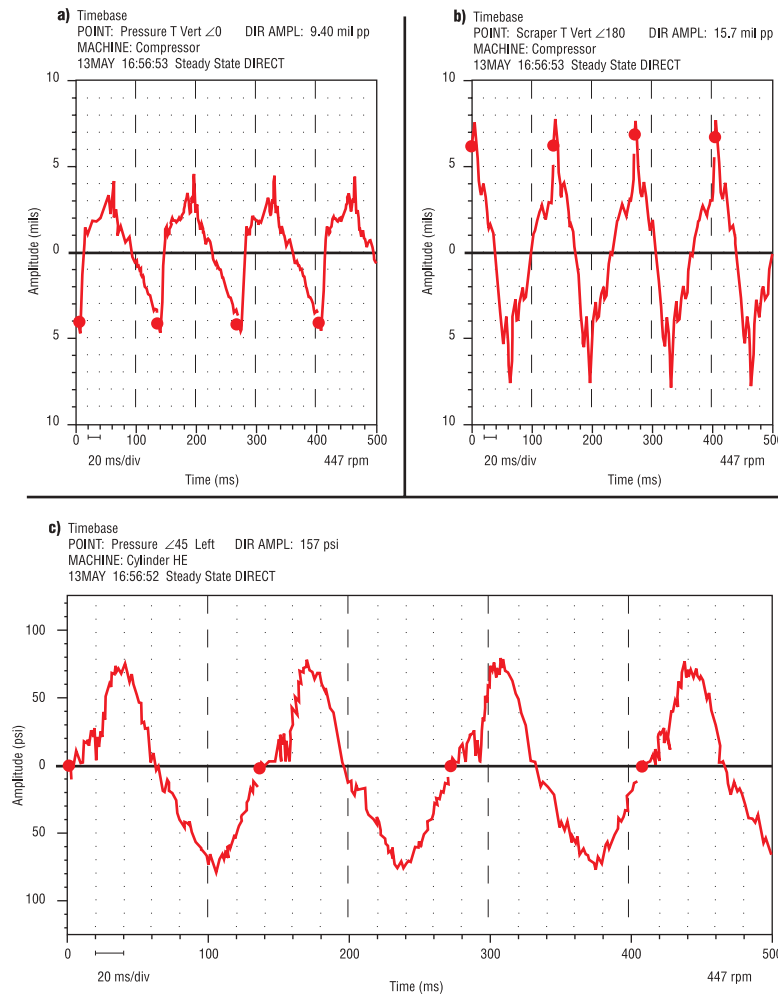
FIGURE 2

monitoring system's shut-down alarm of 7 mils had been bypassed). Peak-to-peak vibration from the temporary probe at the scraper packing (probe C) was observed to vary from approximately 12 mils to 15 mils. Figure 2 shows data collected during high vibration (9.40 mils at the existing pressure packing probe). Figure 3 shows data collected approximately 14 minutes later during low vibration (4.38 mils at the existing pressure packing probe). Cylinder load remained constant during this time. As Figures 2c and 3c show, the ac-coupled signal from the pressure transducer does not show significant changes. The same changes in piston rod displacement were observed when the machine was operated under full load. Figure 4 shows the piston rod vibration (3.24 mils) at probe A. Approximately 3 minutes

DATA COLLECTED AT 4:56 PM DURING HIGH-VIBRATION CONDITIONS FROM a) PROBE A, b) PROBE C, AND c) CYLINDER PRESSURE

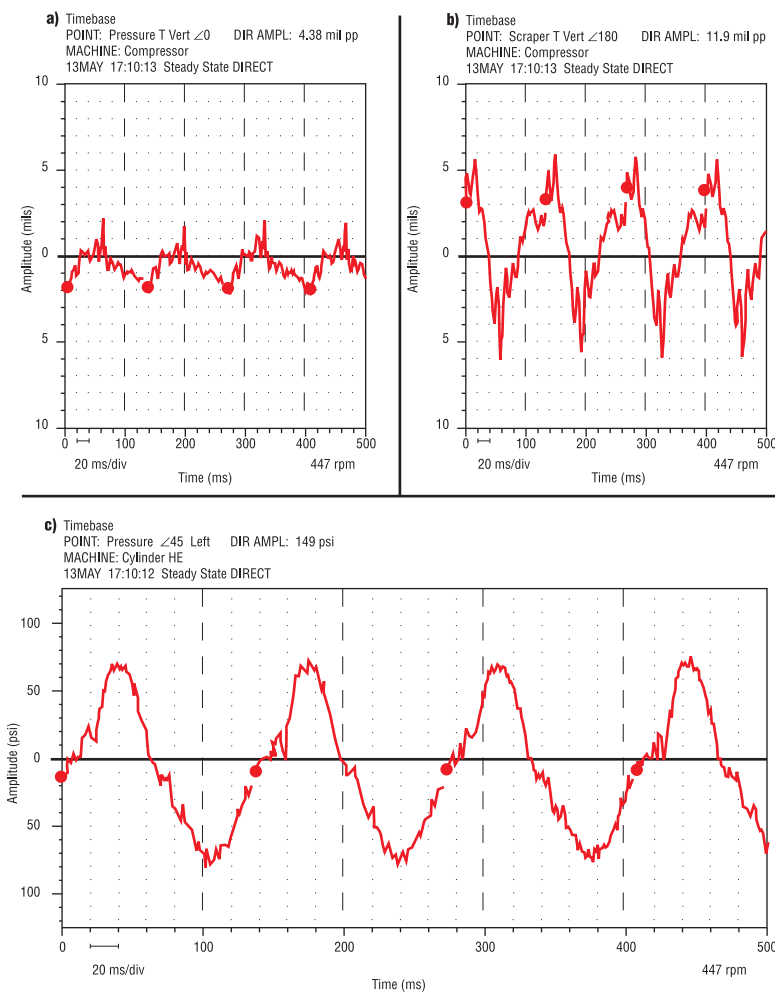
FIGURE 3

DATA COLLECTED AT 5:10 PM DURING LOW-VIBRATION CONDITIONS FROM a) PROBE A, b) PROBE C, AND c) CYLINDER PRESSURE

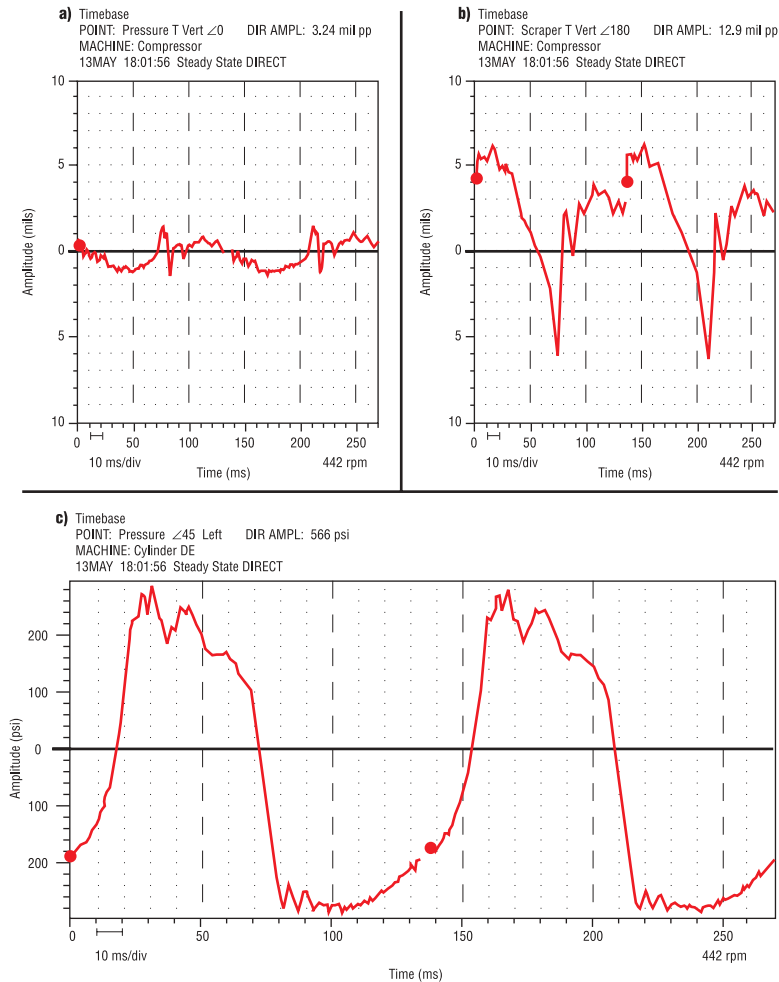
FIGURE 4

later, piston rod vibration at probe A was 7.24 mils (Figure 5). The ac-coupled cylinder pressure is shown in Figures 4c and 5c. Note that cylinder pressure remains essentially unchanged between Figures 4 and 5, yet vibration amplitude more than doubles.

Analysis of the pressure data and vibration data in Figures 4 and 5 revealed that forces acting on the machine did not vary even though the vibration changed. Therefore, stiffness somewhere in the machine was changing. In addition, the piston rod

movement was greater at the crosshead than at the packing case. This analysis indicated excessive clearance between the crosshead and crosshead guide, and excessive clearance between the rider band and cylinder bore. These conclusions were forwarded to the customer and the machine was scheduled for shutdown to permit an internal inspection.

**DATA COLLECTED AT 6:02 PM DURING FULLY LOADED CONDITIONS
FROM a) PROBE A, b) PROBE C, AND c) CYLINDER PRESSURE**

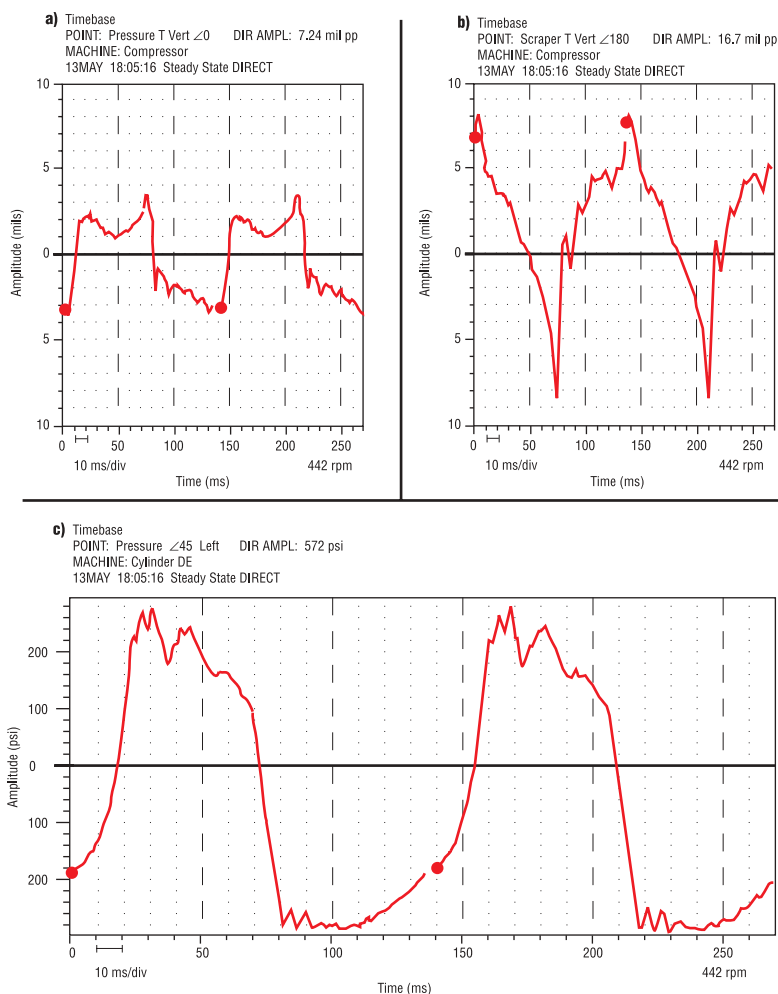
FIGURE 5

**DATA COLLECTED AT 6:05 PM DURING FULLY LOADED CONDITIONS
FROM a) PROBE A, b) PROBE C, AND c) CYLINDER PRESSURE**

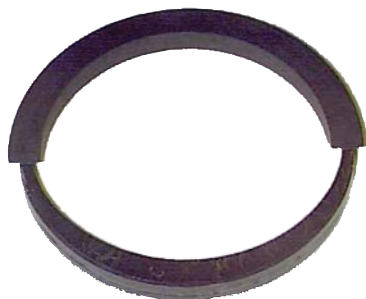
FIGURE 6

The primary problem was determined to be the piston pressure rings. All four were badly worn and showed signs of damage from foreign material. Figure 6 shows a new ring (top) and a worn ring (bottom). The pressure rings also showed significant wear near the 45-degree angle cut. The sides of the pressure rings had scars from foreign material lodged between the ring and the ring groove.

**PISTON PRESSURE RINGS:
NEW RING IS SHOWN ON TOP,
WORN RING ON BOTTOM**

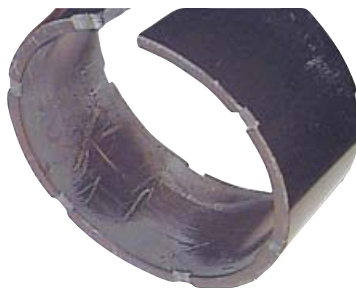
FIGURE 7

In addition to the damaged pressure rings, both rider bands showed deterioration, with scars caused by foreign material lodging between the rider band and piston. Figure 7 shows a rider band and some of the abrasions left by the foreign debris. It is likely that the erratic piston rod vibration readings were caused by debris lodging between the rider bands and piston and later being blown free. Debris trapped between the piston and rider bands reduced the clearance, raised

the stiffness, and lowered vibration at the pressure packing case. With no debris between the rider bands and piston, there was more clearance, less stiffness, and the piston rod vibration increased. The source of this debris was also identified. Immediately prior to the change in piston rod vibration, a valve had failed. It was believed that all the spring pieces and valve plates had been cleaned from the cylinder, but, as was now obvious, some debris still remained inside the cylinder.

**RIDER BAND SHOWING ABRASION
CAUSED BY DEBRIS TRAPPED
BETWEEN RIDER BAND AND PISTON**

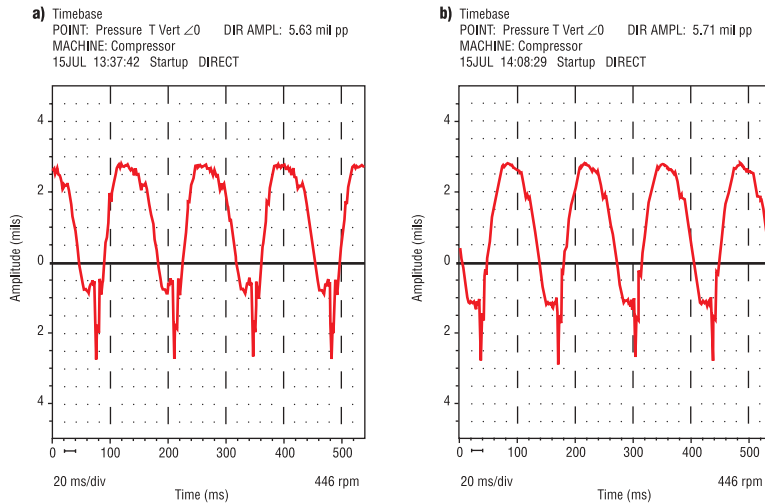
FIGURE 8

Figures 8a and 8b show data acquired (approximately 30 minutes apart) from the existing probe after the machine was put back into service. These plots show a stable repeatable waveform and no indication of changes in piston rod displacement or shape.

**PISTON ROD VIBRATION AT PRESSURE PACKING CASING (EXISTING PROBE A)
UNDER FULLY LOADED CONDITIONS AFTER REMOVAL OF DEBRIS:
DATA COLLECTED AT a) 1:38 PM AND b) 2:08 PM**
